Case Study

Exeloo and Flood Prone Areas

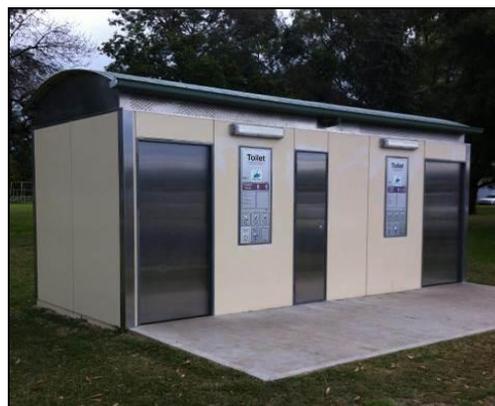
Exeloo toilet units are very robust and made from non-organic materials so they can withstand a flooding environment provided they are well secured to good foundations. There are many examples of Exeloo toilet facilities located on river banks and in flood prone areas where the water has flooded through the buildings. The building itself can normally be cleaned out with a water blaster after the flooding and put back into service but the electronic equipment often needs replacement or repair.

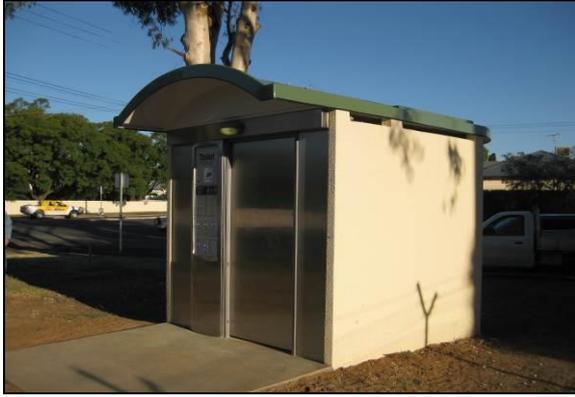
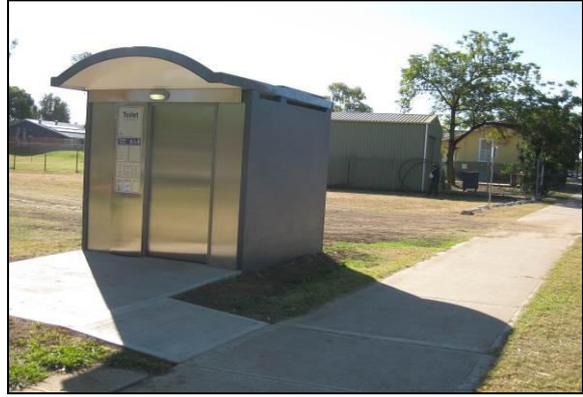
In this case, recognising that the Council would have several days' notice prior to any severe flooding, Exeloo developed a system where all of the electronic components, can be removed from the building by two Council staff within 15 minutes. Each item only needs to be unplugged and unclipped. The process includes the removal of the full control box which was also plugged into a high power socket.
